# Asbestos Register and Inspection Report

**THORESBYCOL : Thoresby College**

**Survey date : 18-Aug-2023**

Type of survey                **Re-Inspection**  
Surveyor                      **Roberts, Tony**  
Survey date                  **18-Aug-2023**

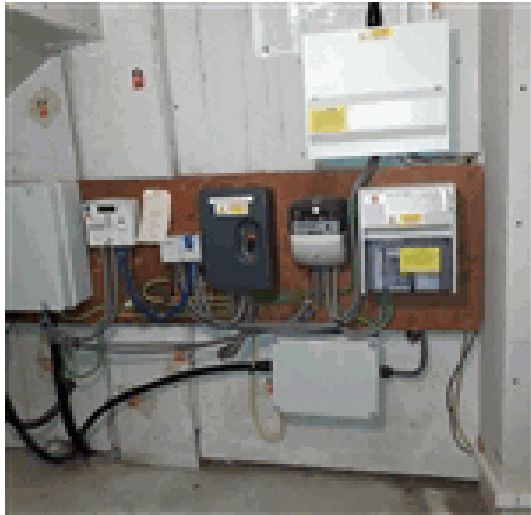
| Reference | 1 | Sample number | B418234 | |

**Seal or Encapsulate**

| Floor | | Room | Cupboard under stairs | |
| Location | Wall | | | |
| Damage/deterioration | Medium damage (2) | | | |
| Asbestos type | Amphibole e.g Amosite (2) | | | |
| Frequency of maintenance | >1 per year (2) | Banding | Medium | |

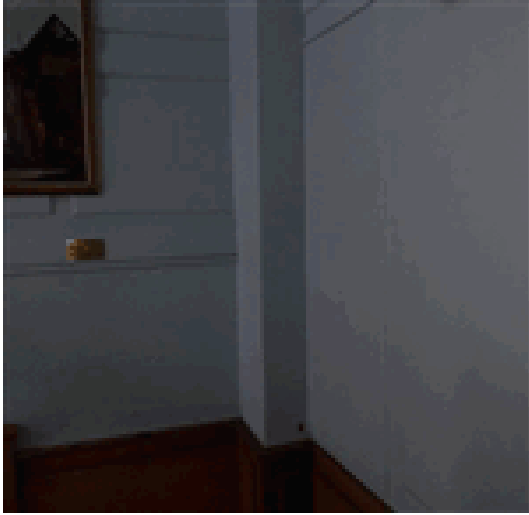
Reference **3** Sample number **B418236**  
Survey date **18-Aug-23** Presumed **No**

Building : **01A Main Building**  
Floor **Room** **Stairwell 2**  
Location **Wall boxing**  
Quantity sampled **4m2** Use **A.I.B.**

Product type **AIB, textiles, gaskets, ropes, paper (2)**  
Damage/deterioration **Good-no damage (0)**  
Surface treatment **Enclosed sprays or lagging/bare cement (1)**  
Asbestos type **Amphibole e.g Amosite (2)**

Material score **5**  
Priority score **7**  
Banding **Low**

**Monitor & Manage**

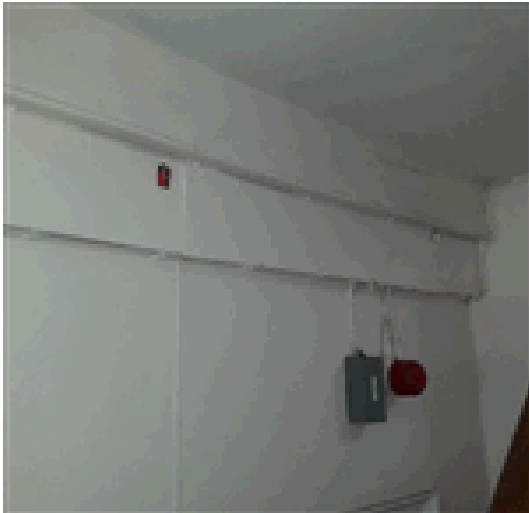
Reference **4** Sample number **REFB418236/1**  
Survey date **18-Aug-23** Presumed **Yes**

Building : **01A Main Building**  
Floor **Room** **Corridor 3**  
Location **Wall boxing**  
Quantity sampled **2m2** Use **A.I.B.**

Product type **AIB, textiles, gaskets, ropes, paper (2)**  
Damage/deterioration **Low damage (1)**  
Surface treatment **Enclosed sprays or lagging/bare cement (1)**  
Asbestos type **Amphibole e.g Amosite (2)**

Material score **6**  
Priority score **7**  
Banding **Low**

**Monitor & Manage**

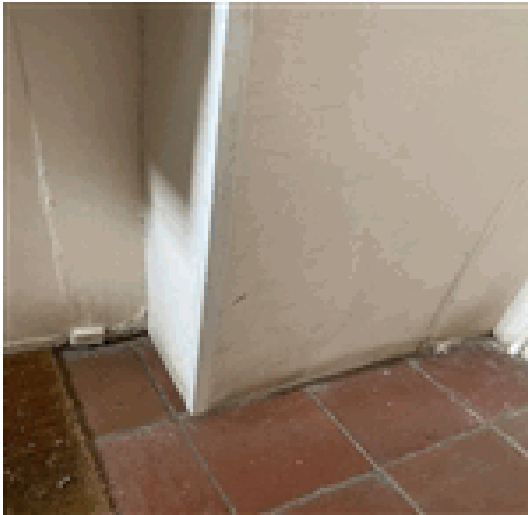
Reference **5** Sample number **REFB418236/2**  
Survey date **18-Aug-23** Presumed **Yes**

Identified as being sealed during re-inspection 26/08/2022  
Repair works carried out by Vertex February/March 2022

Building : **01A Main Building**  
Floor **Room** **Corridor 3**  
Location **Wall boxing**  
Quantity sampled **3m2** Use **A.I.B.**

Product type **AIB, textiles, gaskets, ropes, paper (2)**  
Damage/deterioration **Low damage (1)**  
Surface treatment **Enclosed sprays or lagging/bare cement (1)**  
Asbestos type **Amphibole e.g Amosite (2)**

Average time of use **1 to 3 hours (1)** Material score **6**  
Type of maintenance **Low disturbance (1)** Priority score **9**  
Frequency of maintenance **>1 per year (2)** Banding **Medium**

**Monitor & Manage**

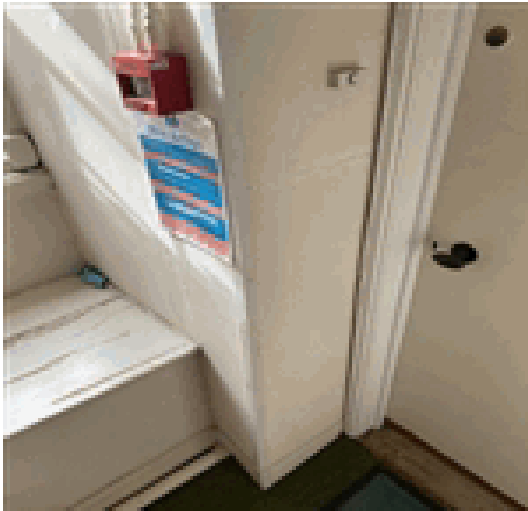
Reference **6** Sample number **REFB418236/3**  
Survey date **18-Aug-23** Presumed **Yes**

Identified as being encapsulated during re-inspection 26/08/2022  
Repair works carried out by Vertex February/March 2022

Building : **01A Main Building**  
Floor **Room** **Stairwell 3**  
Location **Wall boxing**  
Quantity sampled **2m2** Use **A.I.B.**

Product type **AIB, textiles, gaskets, ropes, paper (2)**  
Damage/deterioration **Low damage (1)**  
Surface treatment **Enclosed sprays or lagging/bare cement (1)**  
Asbestos type **Amphibole e.g Amosite (2)**

Average time of use **1 to 3 hours (1)** Material score **6**  
Type of maintenance **Low disturbance (1)** Priority score **7**  
Frequency of maintenance **>1 per year (2)** Banding **Low**

**Monitor & Manage**

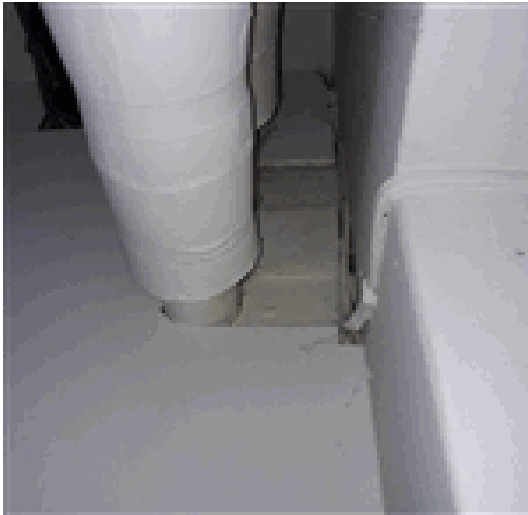
Reference **7** Sample number **REFB418236/4**  
Survey date **18-Aug-23** Presumed **Yes**

Building : **01A Main Building**  
Floor : **Room** **Stairwell 4**  
Location : **Behind wood boxing**  
Quantity sampled : **4m** Use : **A.I.B.**

Product type : **AIB, textiles, gaskets, ropes, paper (2)**  
Damage/deterioration : **Low damage (1)**  
Surface treatment : **Enclosed sprays or lagging/bare cement (1)**  
Asbestos type : **Amphibole e.g Amosite (2)**

Average time of use : **1 to 3 hours (1)** Material score : **6**  
Type of maintenance : **Low disturbance (1)** Priority score : **7**  
Frequency of maintenance : **>1 per year (2)** Banding : **Low**

**Monitor & Manage**

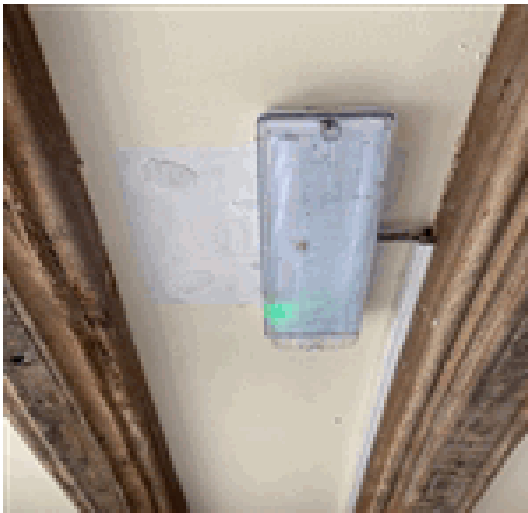
Reference **8** Sample number **B418237**  
Survey date **18-Aug-23** Presumed **No**

Building : **01A Main Building**  
Floor : **Room** **Stairwell 4**  
Location : **Ceiling panels**  
Quantity sampled : **10m2** Use : **A.I.B.**

Product type : **AIB, textiles, gaskets, ropes, paper (2)**  
Damage/deterioration : **Good-no damage (0)**  
Surface treatment : **Enclosed sprays or lagging/bare cement (1)**  
Asbestos type : **Amphibole e.g Amosite (2)**

Average time of use : **1 to 3 hours (1)** Material score : **5**  
Type of maintenance : **Low disturbance (1)** Priority score : **7**  
Frequency of maintenance : **>1 per year (2)** Banding : **Low**

No visible damage identified during re-inspection 26/08/2022  
Repair works carried out by Vertex February/March 2022

**Monitor & Manage**

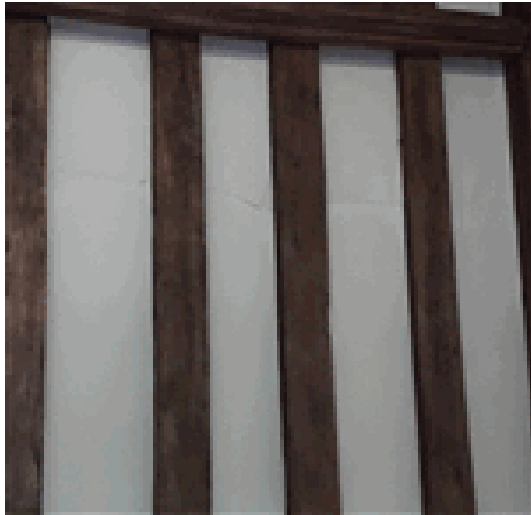
| Reference | 11 | Sample number | B418239 | |

Multiple tears to scrim, and some lack of adhesion to ceiling. (ST 23/08/2021)

| Floor | | Room | Great Hall | |
| Location | Ceiling panels | | | |
| Damage/deterioration | Low damage (1) | | | |

**Monitor & Manage**

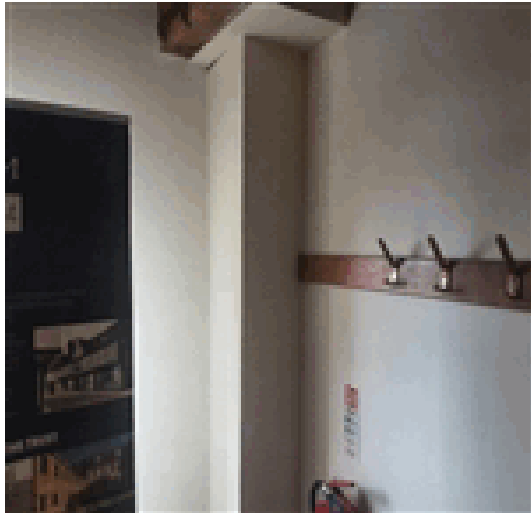
| Reference | 12 | Sample number | REFB418236/5 | |

| Damage/deterioration | Good-no damage (0) | | | |

**Monitor & Manage**

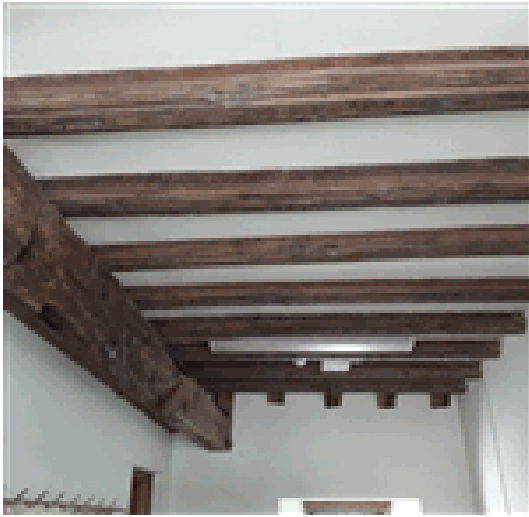
Reference **13** Sample number **REFB418237/1**  
Survey date **18-Aug-23** Presumed **Yes**

Product type **AIB, textiles, gaskets, ropes, paper (2)**  
Damage/deterioration **Low damage (1)**  
Surface treatment **Enclosed sprays or lagging/bare cement (1)**  
Asbestos type **Amphibole e.g Amosite (2)**

Average time of use **1 to 3 hours (1)** Material score **6**  
Type of maintenance **Low disturbance (1)** Priority score **7**  
Frequency of maintenance **>1 per year (2)** Banding **Low**

**Monitor & Manage**

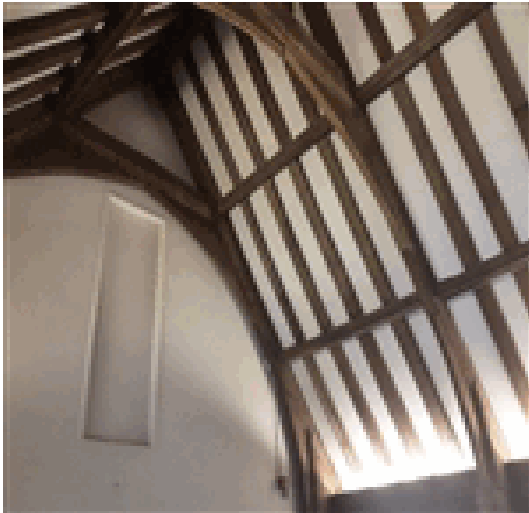
Reference **14** Sample number **REFB418239/1**  
Survey date **18-Aug-23** Presumed **Yes**

Product type **AIB, textiles, gaskets, ropes, paper (2)**  
Damage/deterioration **Good-no damage (0)**  
Surface treatment **Enclosed sprays or lagging/bare cement (1)**  
Asbestos type **Chrysotile (1)**

**Monitor & Manage**

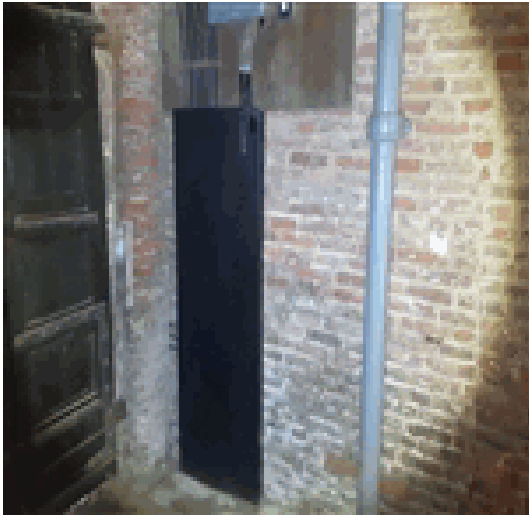
Identified as being encapsulated during re-inspection 26/08/2022  
Repair works carried out by Vertex February/March 2022

Building : **01A Main Building**  
Floor **Room** **Founders Gate**  
Location **Electrical box**  
Quantity sampled **<1m2** Use **A.I.B.**

Product type **AIB, textiles, gaskets, ropes, paper (2)**  
Damage/deterioration **Low damage (1)**  
Surface treatment **Enclosed sprays or lagging/bare cement (1)**  
Asbestos type **Amphibole e.g Amosite (2)**

Average time of use **1 to 3 hours (1)** Material score **6**  
Type of maintenance **Low disturbance (1)** Priority score **7**  
Frequency of maintenance **>1 per year (2)** Banding **Low**

**Monitor & Manage**

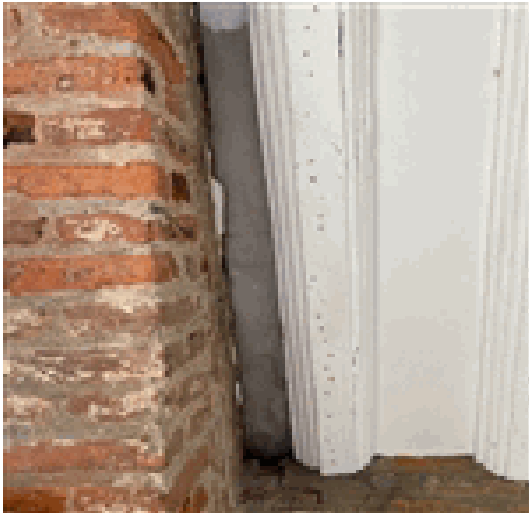
Repair works carried out by Vertex February/March 2022

Building : **01A Main Building**  
Floor **Room** **Founders Gate**  
Location **Ceiling above plasterboard ceiling**  
Quantity sampled **10m2** Use **A.I.B.**

Product type **AIB, textiles, gaskets, ropes, paper (2)**  
Damage/deterioration **Low damage (1)**  
Surface treatment **Enclosed sprays or lagging/bare cement (1)**  
Asbestos type **Amphibole e.g Amosite (2)**

**Monitor & Manage**

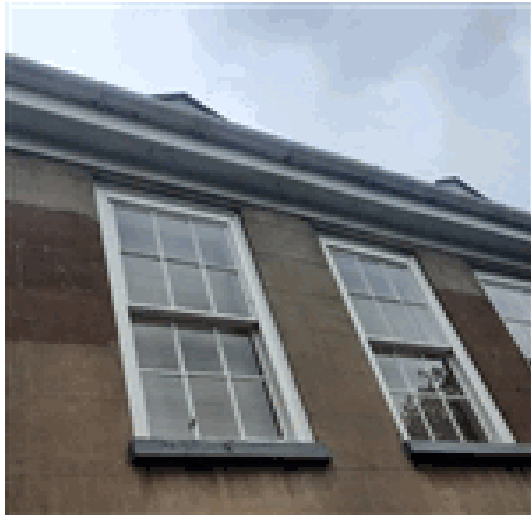
| Reference | 17 | Sample number | |

| Damage/deterioration | Good-no damage (0) | | |
| Frequency of maintenance | ACM unlikely to be disturbed (0) | Banding | Very Low |

**Monitor & Manage**

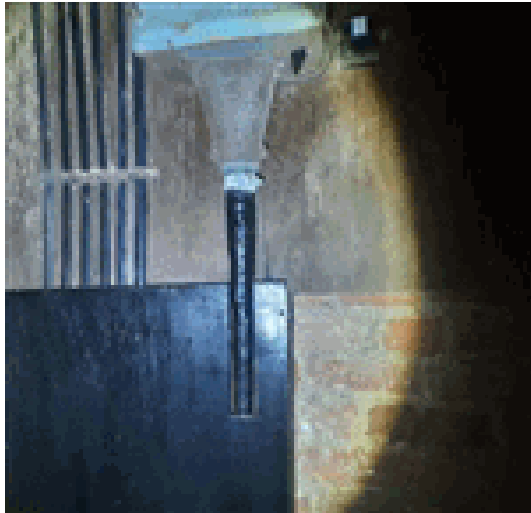
| Reference | 18 | Sample number | |

| Floor | | Room | Founders Gate |
| Damage/deterioration | Low damage (1) | | |

**Monitor & Manage**
